Village of Hussar

2024 PUBLIC MEETING

The **Report Summary** below consists of observations that can range from safety hazards, deficiencies that can cause damage, issues that may require considerable expense, and concerns I would like to draw extra attention to for immediate repairs. This summary is not a detailed listing of every observation made in the report, and reflects importance based on the opinion of the inspector. Please review the entire report as this summary alone does not focus on each and every issue found during this inspection. Repairs not considered typical homeowner maintenance should be completed by a qualified contractor.

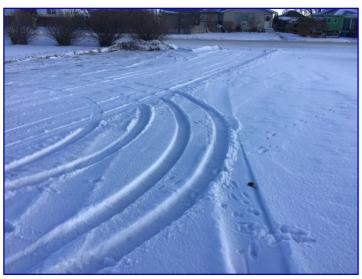
Driveway is in serviceable condition.

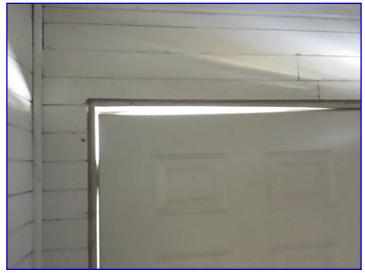
Damage / gaps noted at weatherstripping on exterior doors. Recommend replacing weatherstripping as required to prevent heat loss and pest intrusion.

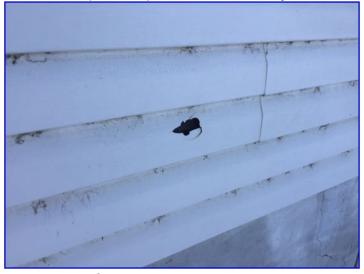
Areas of damage noted to wall cladding.

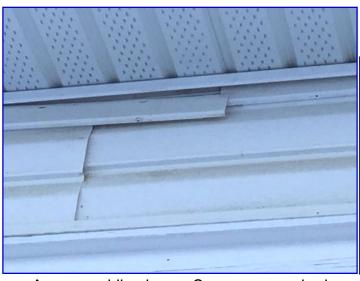
Areas os siding loose. Secure as required

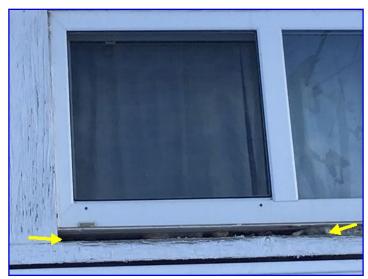
Windows poorly installed. Gaps noted. Recommend repairs

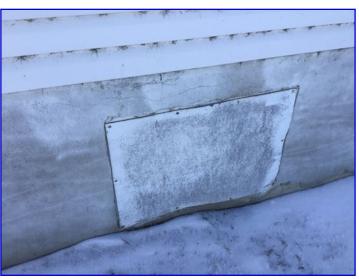
Recommend review of window patches for proper seal.

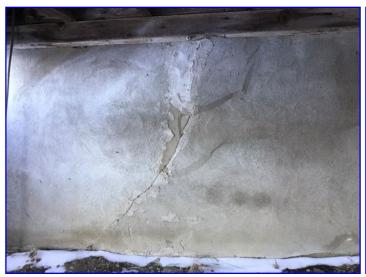
Cracking observed at foundation wall. Vertical hairline cracks are often caused by shrinkage as Recommend further review for repairs by concrete concrete cures, however larger cracks can result from structural movement as a foundation / footing settles. The inspector is unable to determine the length or severity of the crack extension beneath grade as it is not visible or accessible without an invasive investigation. There was no visible evidence of previous moisture or active signs of water penetration in the basement area at the time of inspection unless otherwise noted. Sealing exterior cracks, gaps, or holes in the foundation with an appropriate crack sealer and re-parging as a preventative measure against water and pest intrusion is recommended. If cracks appear to worsen over time, a foundation contractor should be consulted.

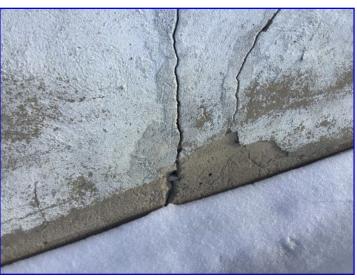
Several cracks noted at foundation wall. contractor.

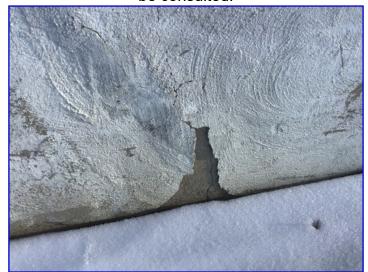
Cement parging flaking/deterioration observed. Parging is an aesthetic coating applied to foundations to protect the foundation wall from premature aging. Suggest review for repair as necessary.

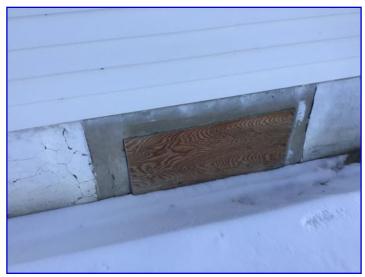
Several abandoned windows boxed in noted.

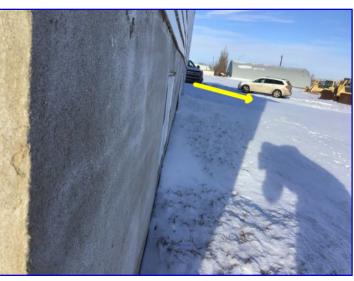
Bowing noted at foundation walls in areas.

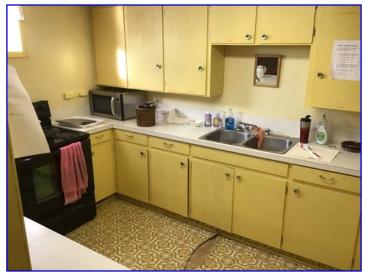
Kitchen floors in fair to poor condition - Visual damage noted to floor surface

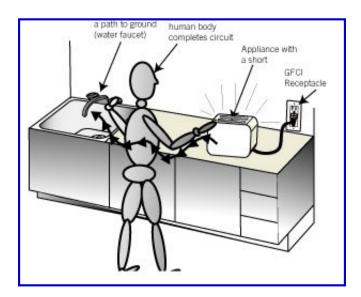
Reverse polarity noted. When electrical deficiencies are noted in this report, a licensed electrician should be consulted for repairs/replacement as needed to ensure safety.

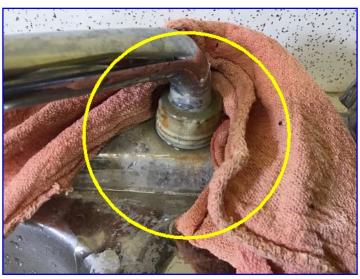
Faucet is leaking. Repair/replace as required. Water damage will occur to counter top if left leaking.

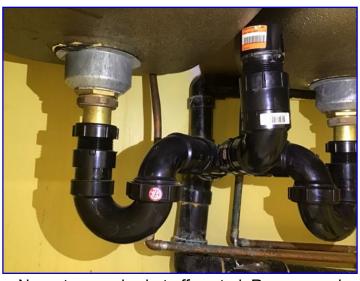
No water supply shut offs noted. Recommend review of waste line installation.

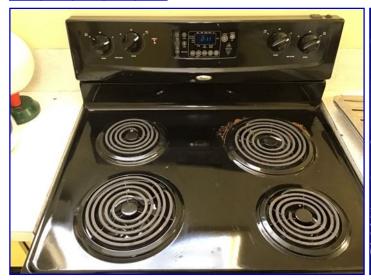
Stove elements slow to heat but working at time of testing.

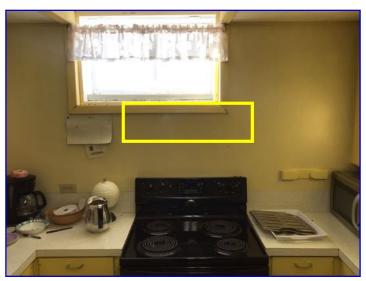
No range hood fan present at stove. Recommend installing exterior vented exhaust hood fan to improve moisture and odour control.

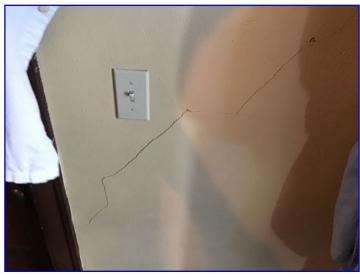
Several areas of plaster cracking noted

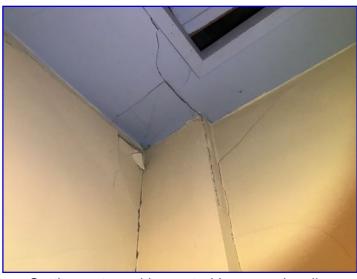
Settlement cracking noted in several walls.

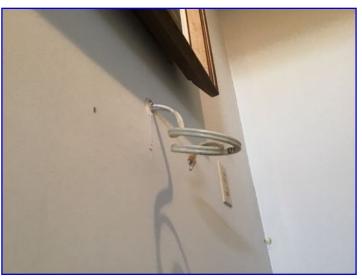
Exposed electrical wiring observed in areas. This is a safety concern as it is subject to "Physical Damage". Exposed electrical wires should be encased in protective cable cover to ensure safety from mechanical damage. Client should consult with a licensed electrician prior to closing for repairs/replacement as needed to ensure safety.

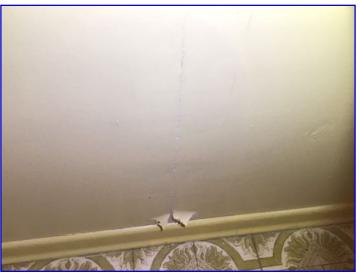
Areas of cracking / peeling noted at Bathroom walls.

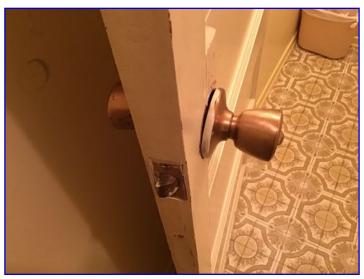
Bathroom handsets loose and require tightening.

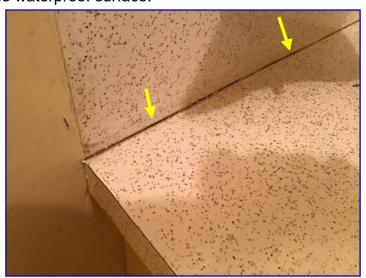
Faucets were run for a period of time. No leaks observed unless otherwise noted. Aerators Recommend regular caulking to prevent water entry behind the waterproof surface.

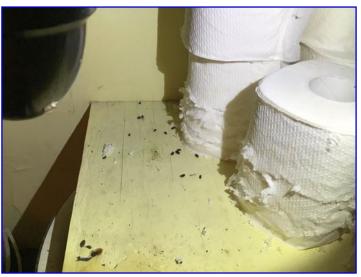
Evidence of rodent activity noted in bathroom cabinet. Recommend further review by extermination contractor.

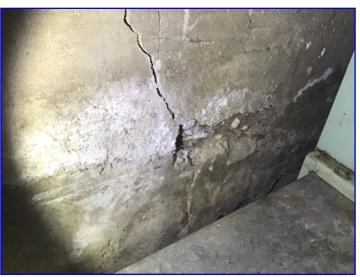
Deterioration noted at areas of the concrete foundation walls. This is often seen with the older homes. Concrete foundations have an approximate life of a hundred years. Due to the condition of the foundation, we recommend full review by a qualified basement contractor prior to close.

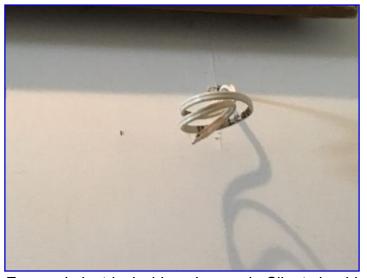
Exposed electrical wiring observed. Client should for repairs/replacement as needed to ensure safety.

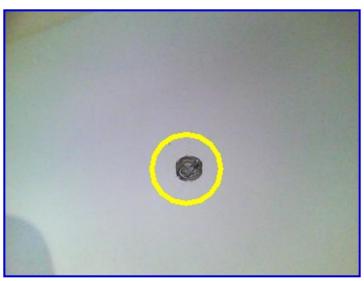
Recommend adding junction box covers for safety where required

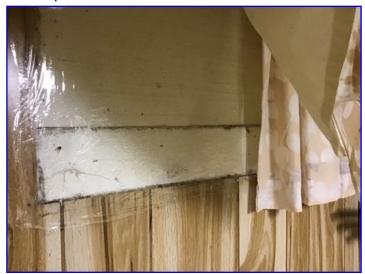
Windows have been blocked with rigid styrofoam. This is a fire hazard and should be replaced.

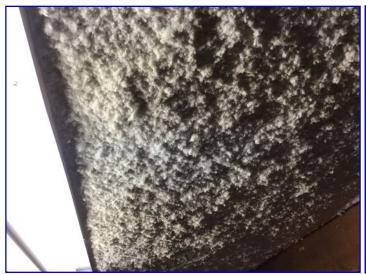
Exposed styrofoam / foam spray observed. This material should be covered with drywall or other fire rated material for safety.

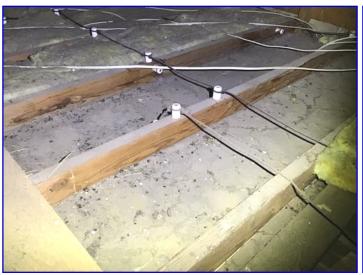
Knob and tube wiring was observed in this home. This type of wiring was standard at the time of construction. Recommend further review by qualified electrician for safety.

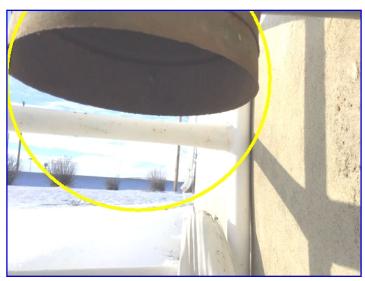
Missing cap at exhaust venting. Replace to prevent down drafting

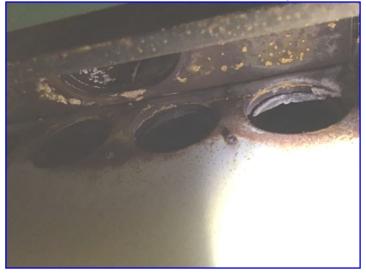
Recommend further review of heat exchanger by qualified furnace technician.

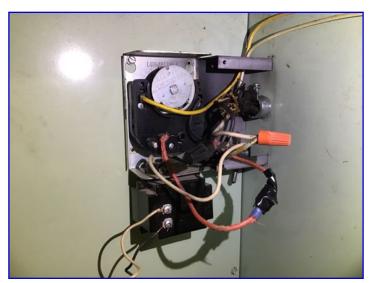
Safety cover missing at furnace. Recommend replacing for safety.

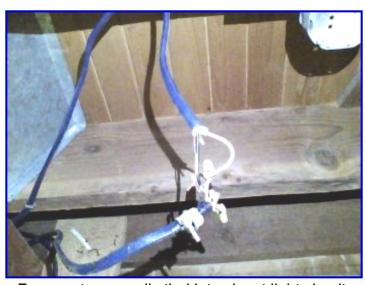
Furnace temporarily tied into closet light circuit. Further repair required.

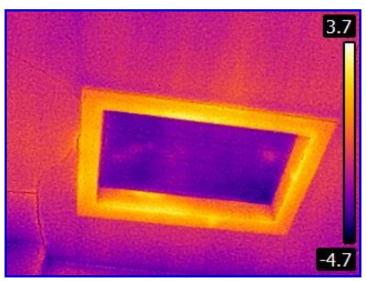
Recommend adding insulation to attic hatch to prevent heat loss.
