Village of Hussar

2024 PUBLIC MEETING

The **Report Summary** below consists of observations that can range from safety hazards, deficiencies that can cause damage, issues that may require considerable expense, and concerns I would like to draw extra attention to for immediate repairs. This summary is not a detailed listing of every observation made in the report, and reflects importance based on the opinion of the inspector. Please review the entire report as this summary alone does not focus on each and every issue found during this inspection. Repairs not considered typical homeowner maintenance should be completed by a qualified contractor.

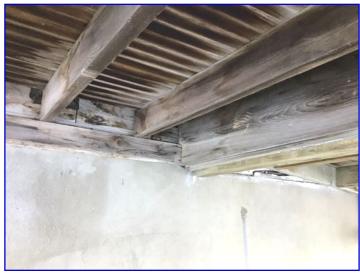
Post deterioration noted at porch / Mudroom framing.

Recommend review of Mud Room framing to confirm structural integrity.

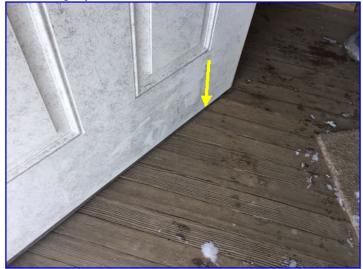
Mudroom door scrapes on floor. Recommend adjustments as required.

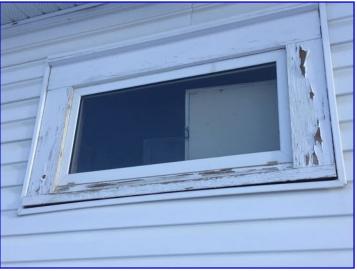
Peeling paint noted. Maintain all exterior wood

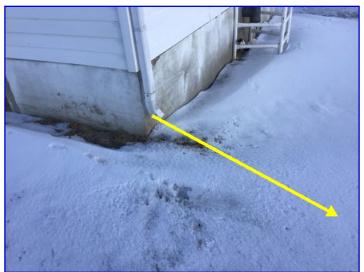
Downspout discharges water at foundation. Recommend installation of 6 foot downspout extension to ensure proper drainage away from foundation to prevent seepage.

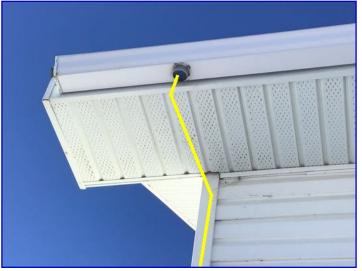
Missing downspouts observed. Suggest downspouts be installed to ensure proper drainage away from the foundation.

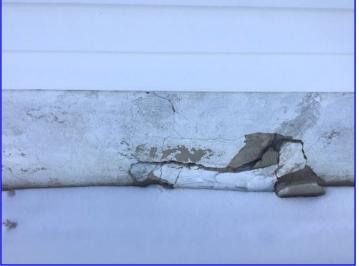
Possible beam pop noted at exterior area of foundation wall. This occurs from beam expansion related to humidity,, weather conditions, and other factors. Recommend further review and repair by qualified contractor to determine required repairs.

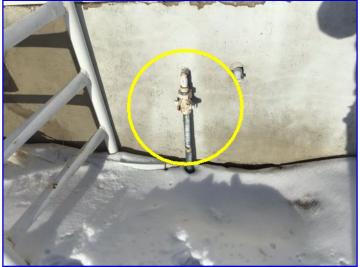
Gas shut off valve at rear of building.

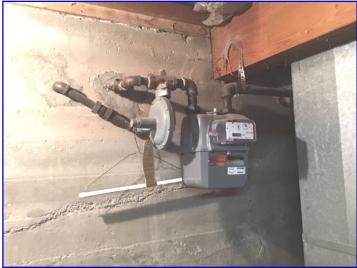
Gas meter is located in the furnace room - this is the main gas shut off to the home

• Gas meter is located in the furnace room - this is the main gas shut off to the home. Recommend relocating to exterior for ease of access.

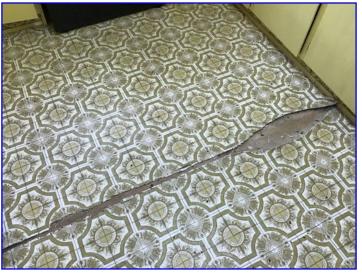
Kitchen floors in fair to poor condition - Visual damage noted to floor surface

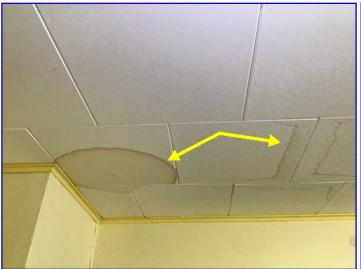
Staining noted at Kitchen ceiling. Dry during thermal scan. In some cases stains can be removed using a 2 parts water- 1 part bleach solution and misting area several times. Inspector is unable determine extent of damage, exact location, or cause of previous leaking due to concealed areas, as this inspection is non-invasive in nature. Recommend further invasive review by qualified contractor if concerned.

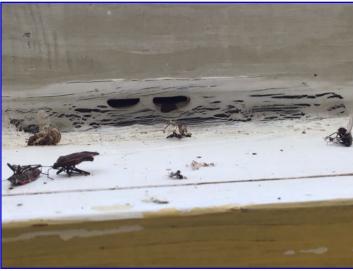
Previous moisture evidence noted on windows in home. Peeling paint / split caulking observed. Recommend repairing, monitoring humidity levels in the home and adjusting humidistat as required

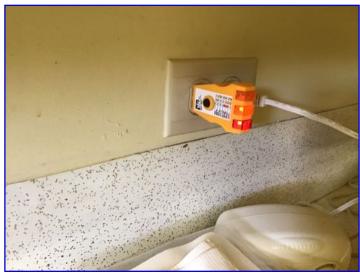
Reverse polarity noted. When electrical deficiencies are noted in this report, a licensed electrician should be consulted for repairs/replacement as needed to ensure safety.

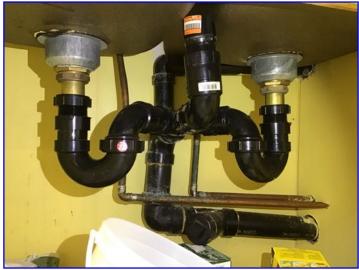
No leaks at traps or drains observed. Water was Air Admittance Valve vent observed at waste line. run for some time to fully test for problems. In some cases plumbing venting is not visible as located inside the wall. Concealed areas excluded as part of the inspection.

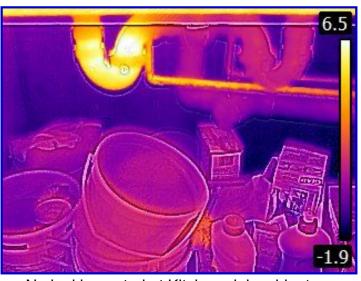
No leaking noted at Kitchen sink cabinet on Thermal image

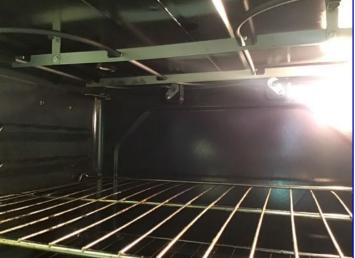
Broil element very slow to heat..

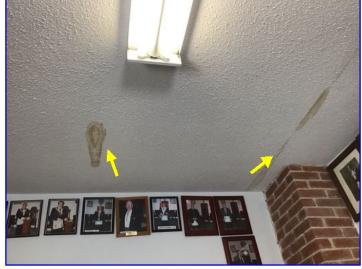
Staining noted at ceiling. Dry during thermal scan. Staining noted at ceiling. Dry during thermal scan. In some cases stains can be removed using a 2 parts water- 1 part bleach solution and misting area several times. Inspector is unable determine area several times. Inspector is unable determine extent of damage, exact location, or cause of previous leaking due to concealed areas, as this inspection is non-invasive in nature. Recommend further invasive review by qualified contractor if concerned.

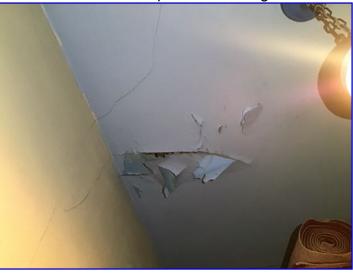
Blown out ceiling plaster noted. Recommend repairs

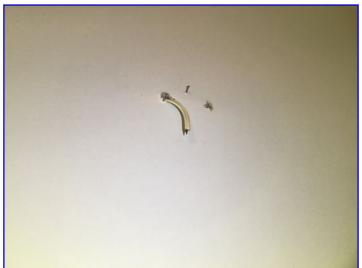
Exposed electrical wiring observed in areas. This is a safety concern as it is subject to "Physical Damage". Exposed electrical wires should be encased in protective cable cover to ensure safety from mechanical damage. Client should consult with a licensed electrician prior to closing for repairs/replacement as needed to ensure safety.

Repair exposed wiring for safety.

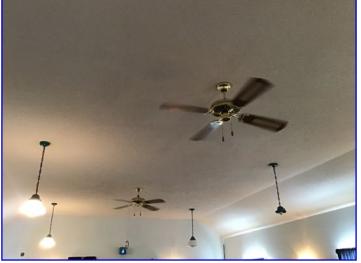
Ceiling fans in hall noisy when operating.

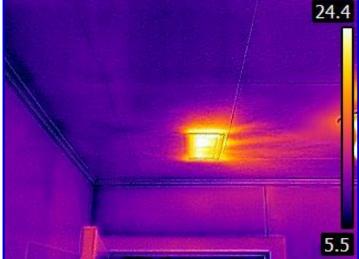
Main Washroom ceiling dry on Thermal scan

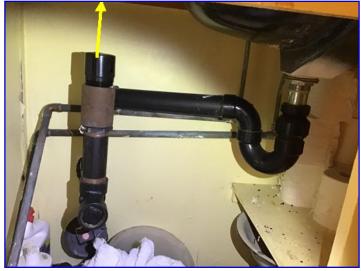
Air Admittance Valve vent observed at waste line. Installation of AAV should be installed above flood rim of sink.

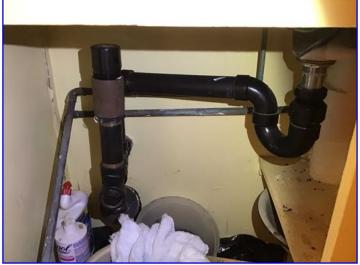
No leaks observed at Main Washroom sink during the inspection.

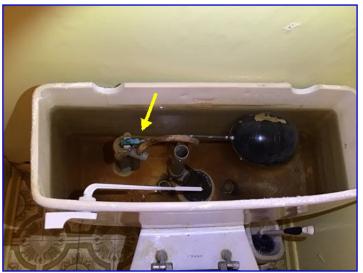
Fill valve / flapper in toilet tank causing toilet to run continuously. Requires adjustment or repair for proper flushing and to prevent water loss.

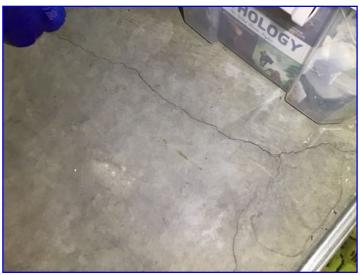
Cracking noted in areas of slab. Recommend consultation with qualified contractor should condition worsen or water intrusion occur.

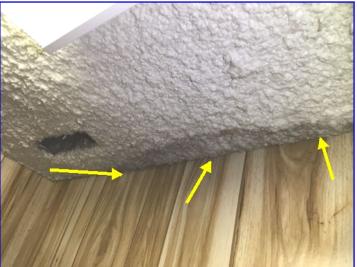
Areas of staining noted.

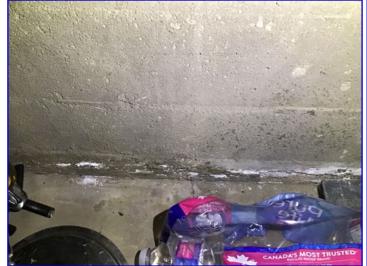
Efflorescence observed at walls / slab. This is a white mineral deposit left behind from water infiltration.

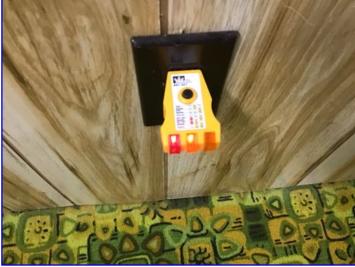
Reverse polarity observed at receptacles in basement. Recommend addressing by a qualified consult with a licensed electrician prior to closing electrician

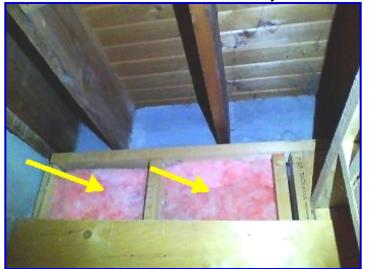
No vapour barrier noted at insulation. This can allow moisture to accumulate behind insulation batts.

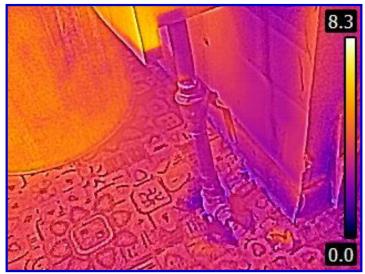
No leaks observed at main valve on Thermal Image at the time of the inspection.

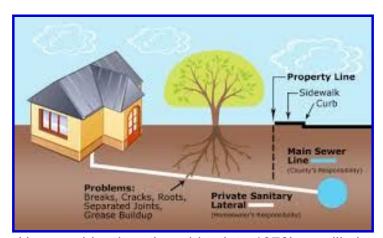
Homes older than the mid to late 1970's are likely to have under ground cast iron, clay, and asbestos composition sewer lines. These are often susceptible to rust and deterioration from the inside and root intrusion from mature trees. It is

to have under ground cast iron, clay, and asbestos composition sewer lines. These are often susceptible to rust and deterioration from the inside and root intrusion from mature trees. It is strongly recommended that the buyer contract a qualified plumber to scope the sewer lines prior to close, as any failure within your property line could lead to expensive repairs for which you may be liable. Guarantees or predictions of sewer line condition cannot be provided by the home inspector as they are not accessible.

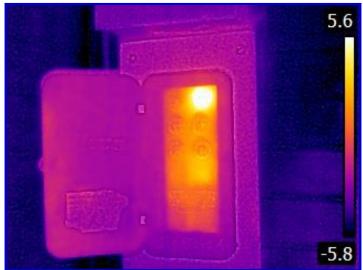
Thermal Image of panel - No issues during inspection

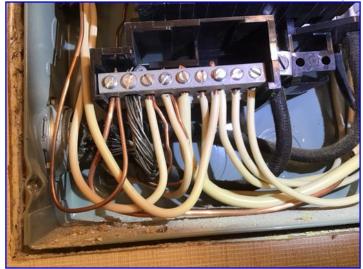
Copper branch wiring noted

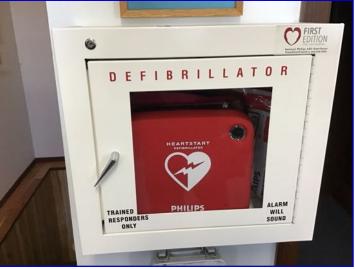
Defibrillator noted.

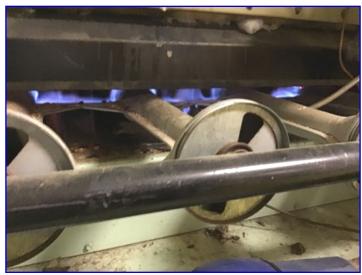
Burner chamber appears in serviceable condition on day of inspection. Annual clean/service by a qualified HVAC technician is recommended on possession and then ongoing annually. Heat exchangers are not visible as they are an internal component of the furnace and can not be inspected properly without disassembling the furnace. As this is not an invasive inspection, heat exchanger condition is not part of this inspection - An HVAC contractor should be consulted to inspect the internal components of the furnace if concerned.

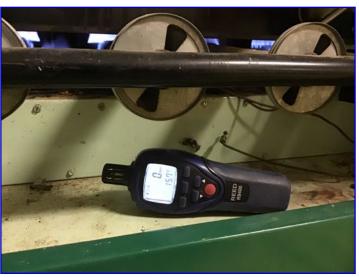
Carbon monoxide reading was ZERO during inspection.

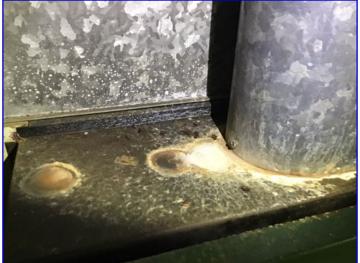
Recommend further review of furnace.

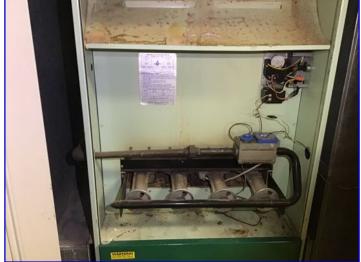
No record of recent service observed. Recommend cleaning and service by a qualified HVAC contractor on possession, and annually thereafter for efficient operation of system.

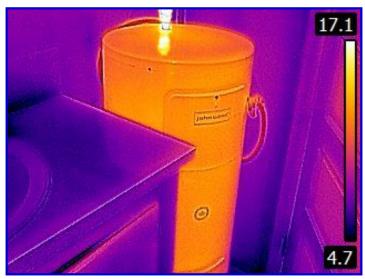
No leaks observed at hot water tank during the inspection - Tank is fully thermal scanned

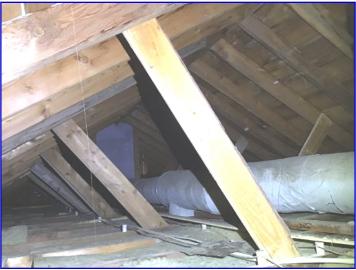
Framing appears serviceable in attic area where visible from ladders edge with flash light. Unable to determine condition of framing in areas covered by insulation or behind obstructions. The roof framing consists of stick framed rafters or a factory- built truss system, comprised of components comprised of chords, webs, and struts that are connected by wood or metal gussets, which are nailed or glued in place. Each component of the truss system is designed for a specific purpose, and cannot be removed or modified without compromising the integrity of the entire truss. The lowest component, which is called the chord and to which the ceiling drywall is attached, can move by thermal expansion and contraction and cause creaking sounds, which are more pronounced in the mornings and evenings along with temperature changes. Such movement has no structural significance, but can result in small cracks or drywall pops.

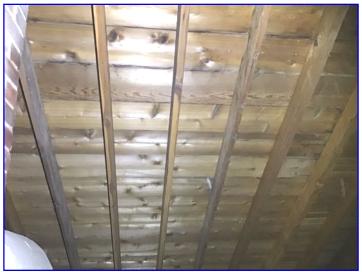
The sheathing was visually inspected and appeared dry on the day of the inspection. (we can only comment on what is visible and accessible areas from the attic hatch at the ladders edge)

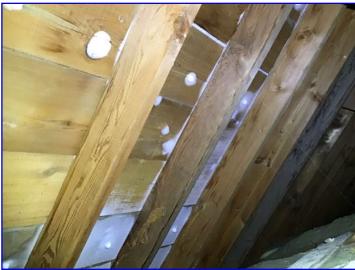
Frost / ice build up noted at sheathing and framing - Common causes are heat loss into attic area and or poor ventilation. This can cause moisture to drip onto ceiling below resulting in staining when temperatures warm up and melts frost / ice. This phenomenon is often referred to as attic rain.

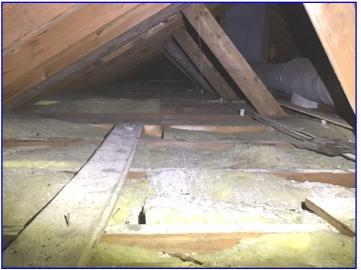
Suggest adding additional insulation in the attic to Missing insulation noted in several areas of attic. reduce heat loss.

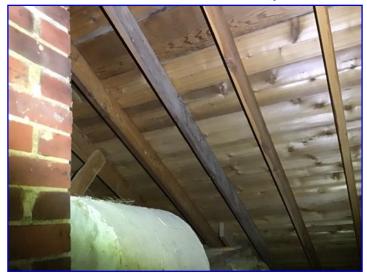
Attic should be reviewed at least twice per year to ensure ventilation openings are clear and to ensure development of organic growth is kept in check
